Name Of Dam: UPPER NORTH RIVER NO. 76 (ELKHORN LAKE)

Location: AUGUSTA COUNTY, VIRGINIA

Inventory Number: VA. NO. 01506

PHASE I INSPECTION REPORT

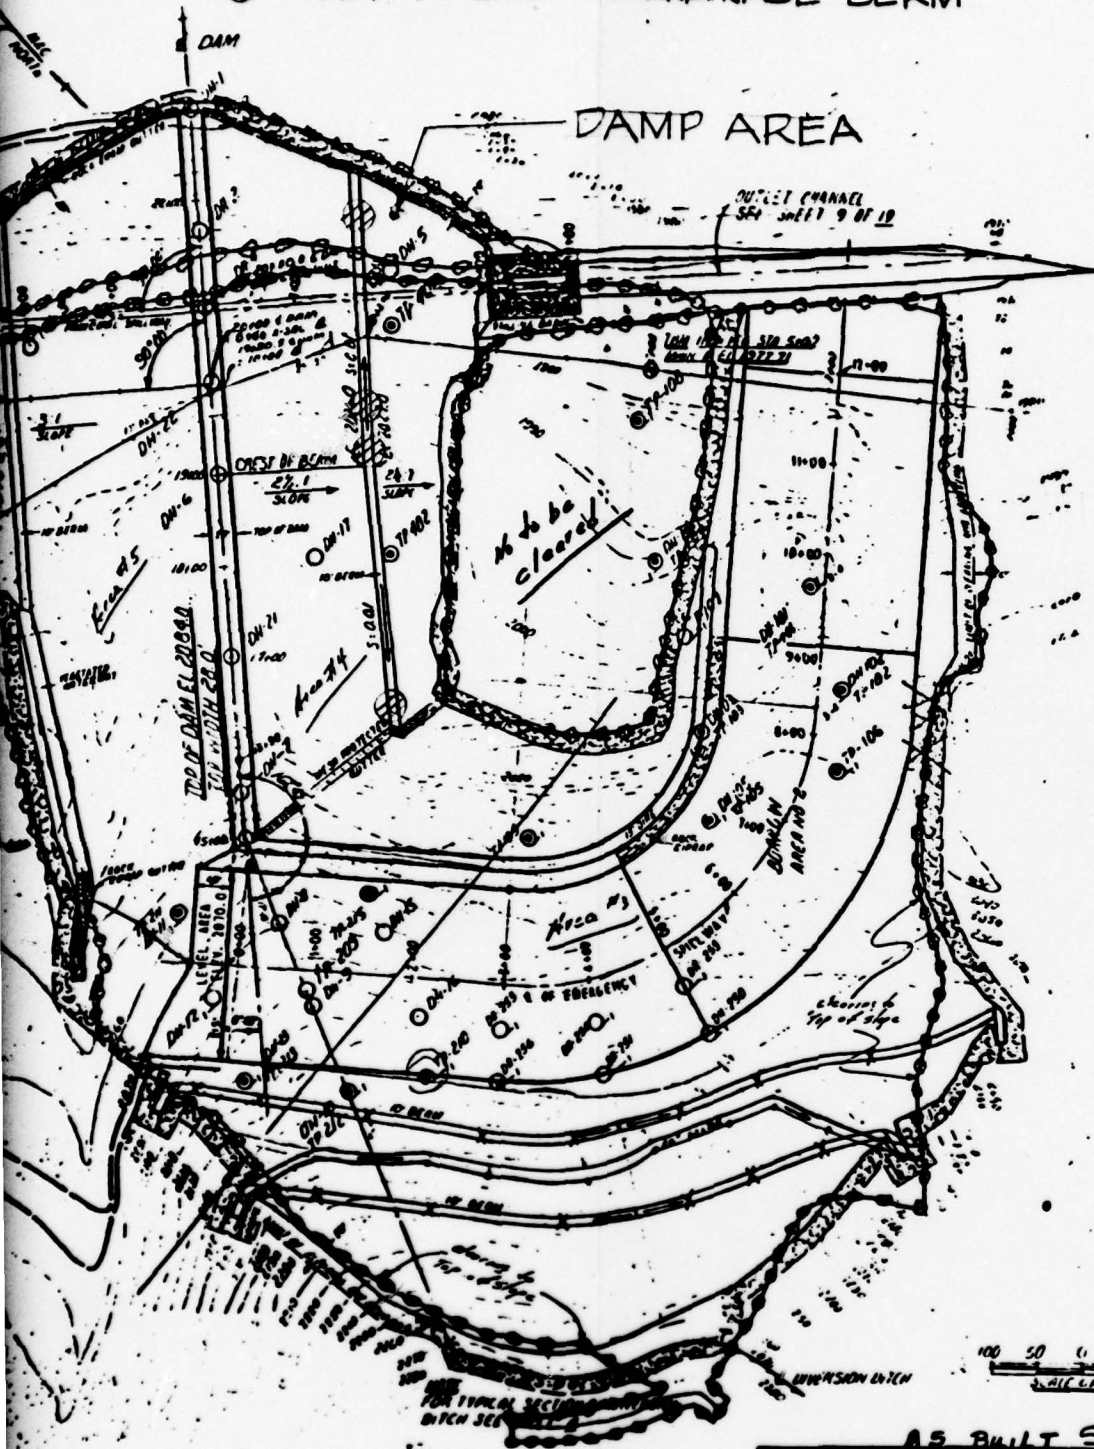
AS BUILT SHEET 2

The area of damp soil illustrated on Sheet 2, Appendix I, is believed to occur because of seepage of the water ponded above in the drainage berm. This condition is not believed to be related to seepage through the dam.

⊙ WET AREAS ON DRAINAGE BERM
